Machias

East Machias at Factory Road

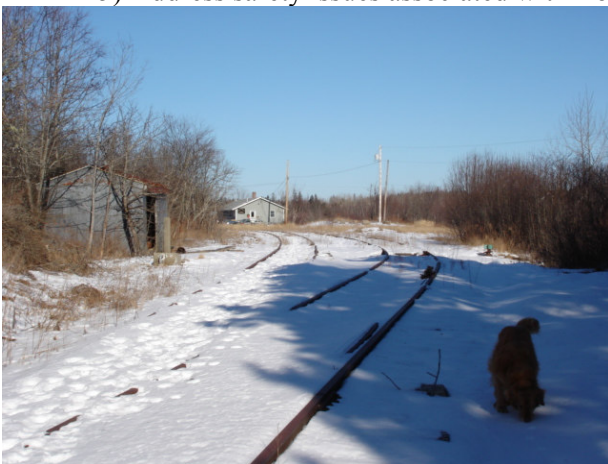
The maximum width dimension for onsite parking is about 50 feet; the siding extends parallel to the rails at that width for at least 200 ft. The siding narrows before crossing Factory Road, therefore, a short access road (approx 100 feet in length) from Factory Road to the parking area would be needed.

Looking east along toward Factory Road.

- 1) Research and address encroachment issues on the site's eastern bound.
- 2) Make use of the site's high visibility location with interpretive signage and trail maps.
- 3) Develop trailhead facilities including parking for at least 15 vehicles, a picnic area, and possibly public facilities;
- 4) Wayfinding signage from Route One and Route 191.
- 5) Address safety issues associated with Route 1 crossing.

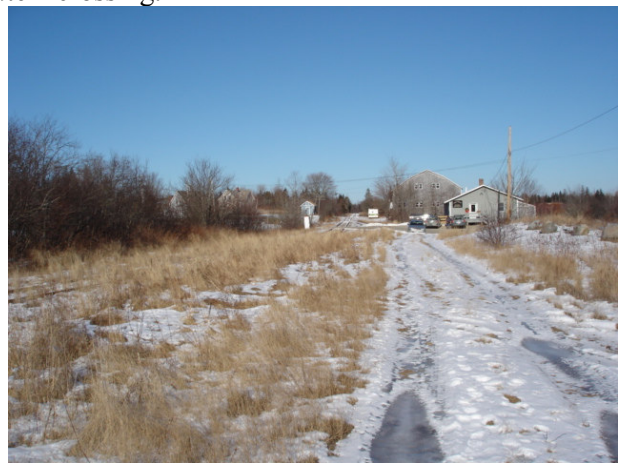
Adjacent to the site on Factory Road, there is a gravel parking area that appears to be overflow parking for medical offices across the street. An access road for trailhead parking would probably have to cross this existing parking area. There is also an unimproved ROW adjacent and possibly crossing the southern bounds of the site. Adjacent to the site on the southeast is a mound of earth with a protruding standpipe. There is also what appears to be an old utility shed on the site. Dumping and underground utilities do not appear to be issues at this site.

ROW and mound along south edge of siding.

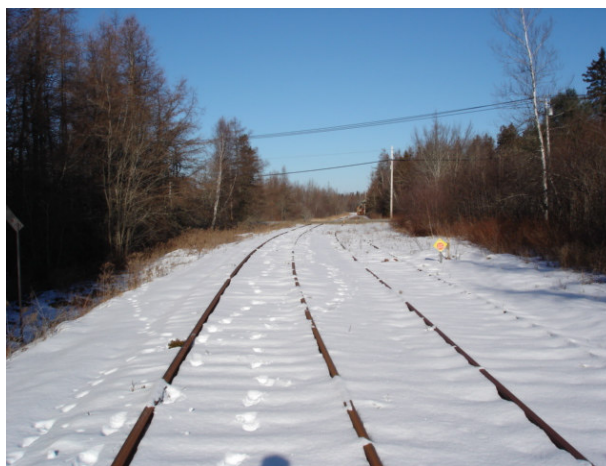
Site Constraints: The site is narrow and long, with a maximum width of less than 25 feet (excluding the trail corridor). The siding narrows before crossing Route 191, therefore, additional land may need to be acquired in order to widen the throat for vehicular entry. Sight lines along the Route 191 corridor provide good visual access for turning traffic.

The existing siding area is flat and will require little or no clearing. The site is surrounded on four sides by forested and semi-forested wetlands; however, the site itself is elevated above the level of surrounding wetlands and appears to be relatively dry. Development of this site may require wetland impacts, especially to open the throat for vehicular access to trailhead parking.

Looking east toward Route 191 along siding.

- 1) Widen throat for safe vehicular access.
- 2) Parking for snowmobile/ATV trailers.

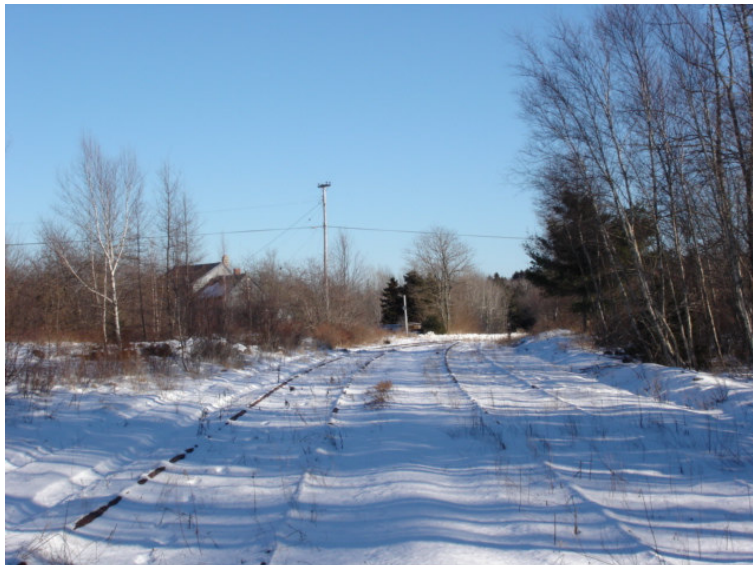
Site Constraints: The existing siding does not narrow before crossing Marion Station Road, therefore vehicular access directly onto trailhead parking would be relatively straight forward. Though the site is relatively narrow (approx. 30 feet), the length of the siding would provide ample room for parking. In addition, there would ample room for this site to accommodate a sheltered picnic areas and public facilities. Sight lines along the Marion Station Road corridor provide good visual access for turning traffic.

There is significant dumping along the north side of the trail corridor that would need to be cleared. Wetlands and underground utilities do not appear to be issues at this site.

Looking east from the former station area toward Marion Station Road.

- 1) Consider this site for subsequent development of a small parking area (~5 vehicles) and picnic area.
- 2) Wayfinding signage from Route 1 in Dennysville and East Machias and Route 191 in Marion Twp.

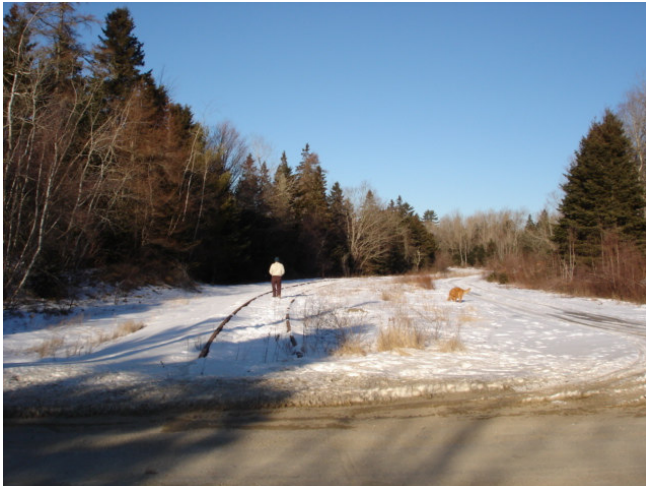
The adjacent site of the former Dennysville Station is currently being used for storage of vehicles and excavating equipment; there is also a large, unstable gravel bank on the former station site. Both that station and an existing access road to the former station are posted as private; fencing may be needed to provide a buffer between the trailhead and the adjacent landowner. There may be encroachment issues with the existing ROW.

Rail corridor (left) and private ROW to former station (right).

- 1) Coordinate with ongoing trail planning in Dennysville.
- 2) Research and address potential encroachment issues with existing ROW.
- 3) Buffering to reduce visual nearby industrial uses should be considered.

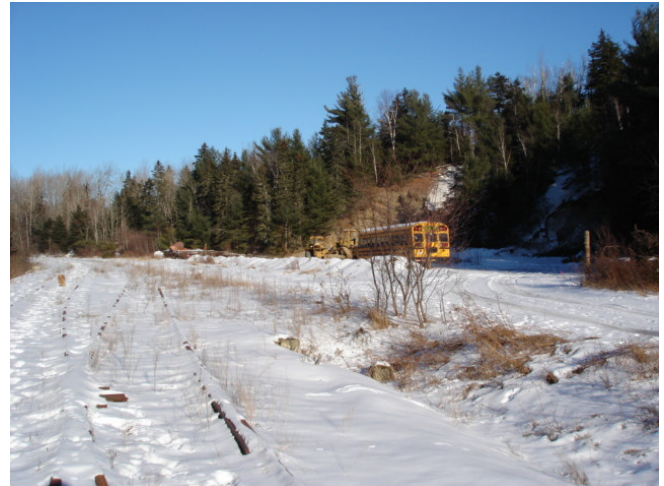
The existing siding area is flat and would require little or no clearing. There were no signs to indicate that the site itself is on a designated wetland, however the westerly edge of the site runs downhill to a stream; run-off may be a potential issue.

Siding area (left) and former station (right).

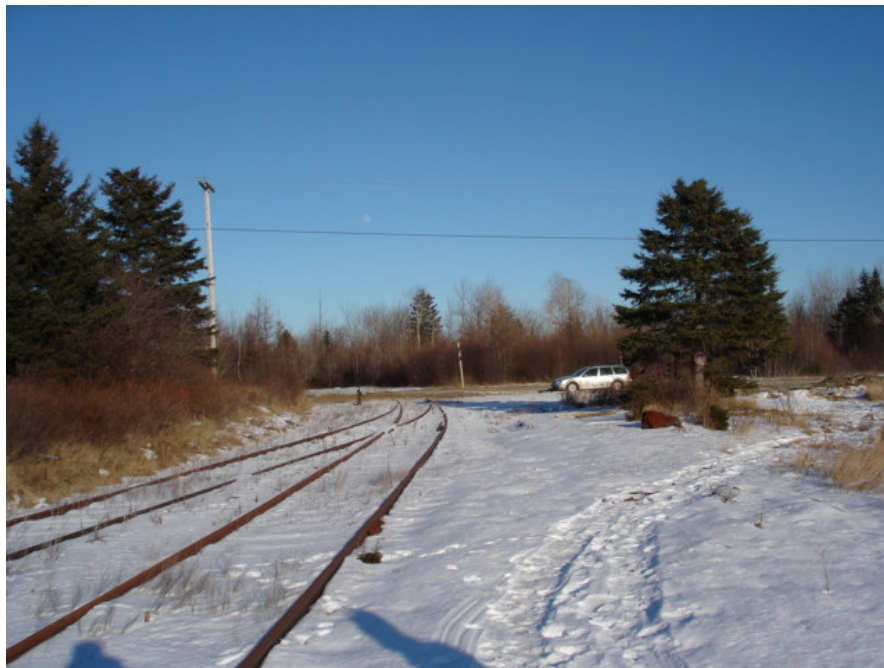
The existing siding does not narrow before crossing Route 214. The maximum width of the existing site exceeds 75 feet narrowing to a “V” 250+ feet south of Route 214. There is ample room for parking and other facilities at this location. Sight lines along Route 214 corridor provide good visual access for turning traffic.

Site Constraints: The existing siding area is flat and would require little or no clearing. There were no signs to indicate that the site itself is on a designated wetland, however there is a near by stream beyond the westerly edge of the site. The site itself sits in a low lying area and run-off impacts the stream and associated wetlands may be a potential issue.

Looking north toward Rt. 214 from the siding.

- 1) As the eastern terminus of the trail, this site should have interpretive signage and trail maps.
- 2) Public facilities and an emergency phone or pay phone should be considered.
- 3) Gravel parking area for 15 to 20 vehicles.
